**CEDAR POINTE
CONDOMINIUM
ASSOCIATION**

CARY, NC

SEPTEMBER 15, 2022

**FULL RESERVE
STUDY UPDATE**

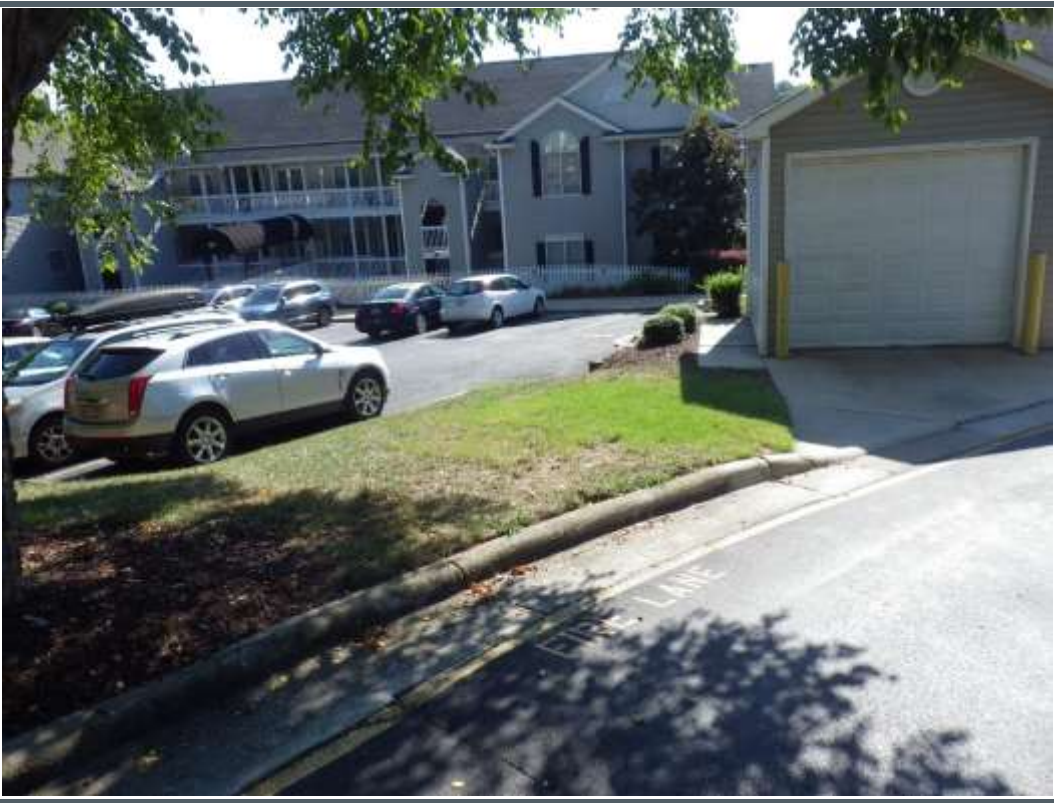
Description
Area of proposed concrete stair to provide access to the dumpster area
Photo No. 10

A short section of worn walking path connects the main drive aisle to the parking lot near the new dumpster corral, and we understand there is a plan to install a new concrete stair at this location, to include a handrail. We have included funds for this project to be performed in 2024.

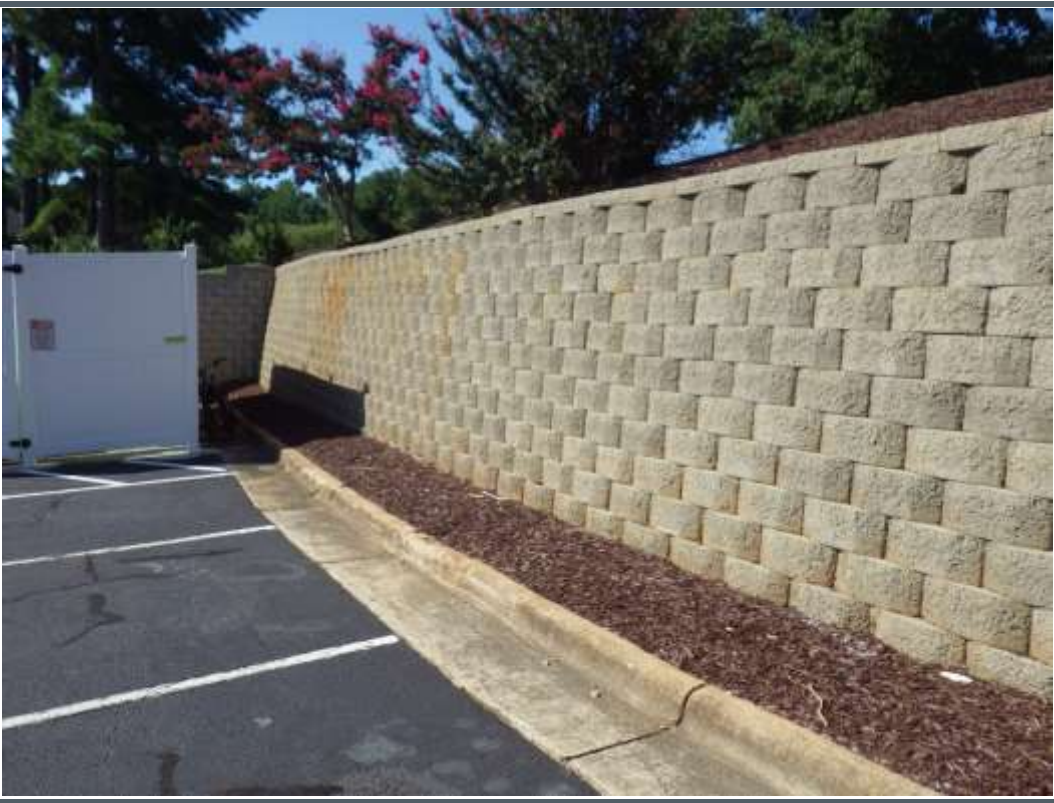
Photo No.
12

Segmental block masonry retaining wall (Phase 2)

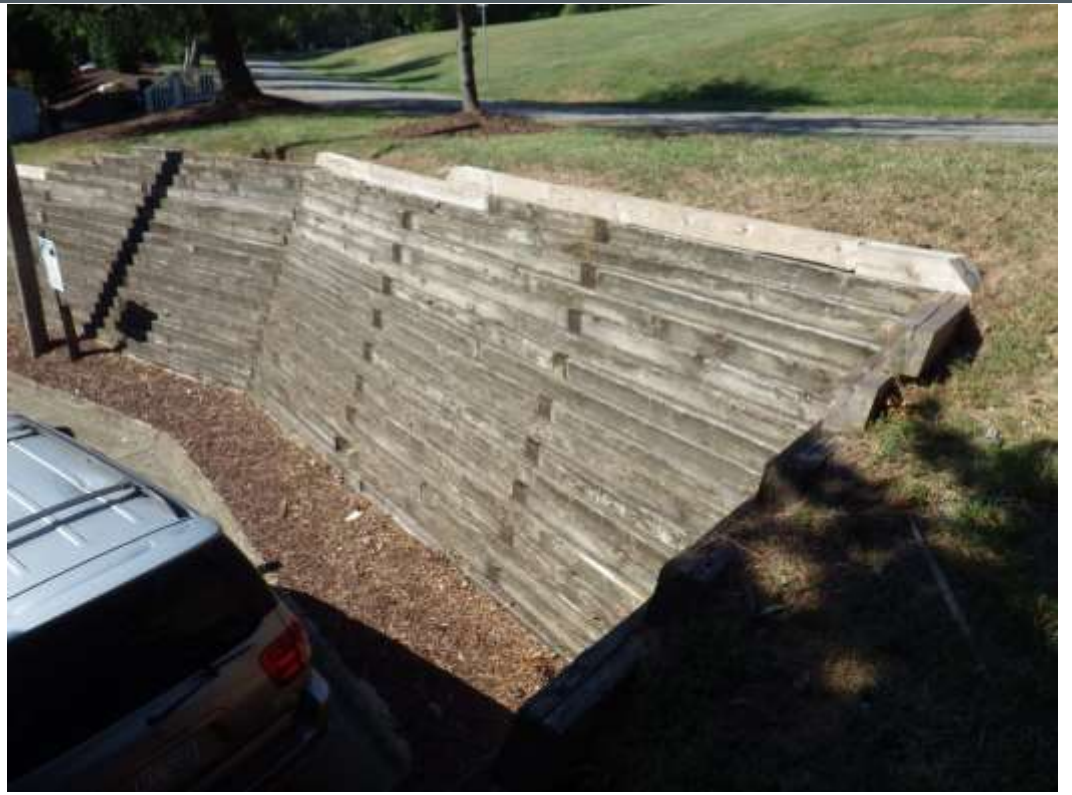
Photo No.
14

Timber retaining wall,
phase 4 of proposed
replacement (2023)

Retaining walls are installed along the western side of the parking lots to accommodate topographical changes. The walls were formerly of timber construction, and phased replacement with segmental block masonry is in progress. The two northern retaining walls have been completed, and a third section (north of building 600) is also scheduled to be replaced in 2022. The southern-most retaining wall (south of building 600, west of building 900) will be replaced in 2023. We also understand there is a plan to install a new retaining wall to the east of building 300 within the next five years. We have included funds to complete the retaining wall installation projects in 2023 (phase 4, south of bldg. 600), and 2025 (east of bldg. 300).

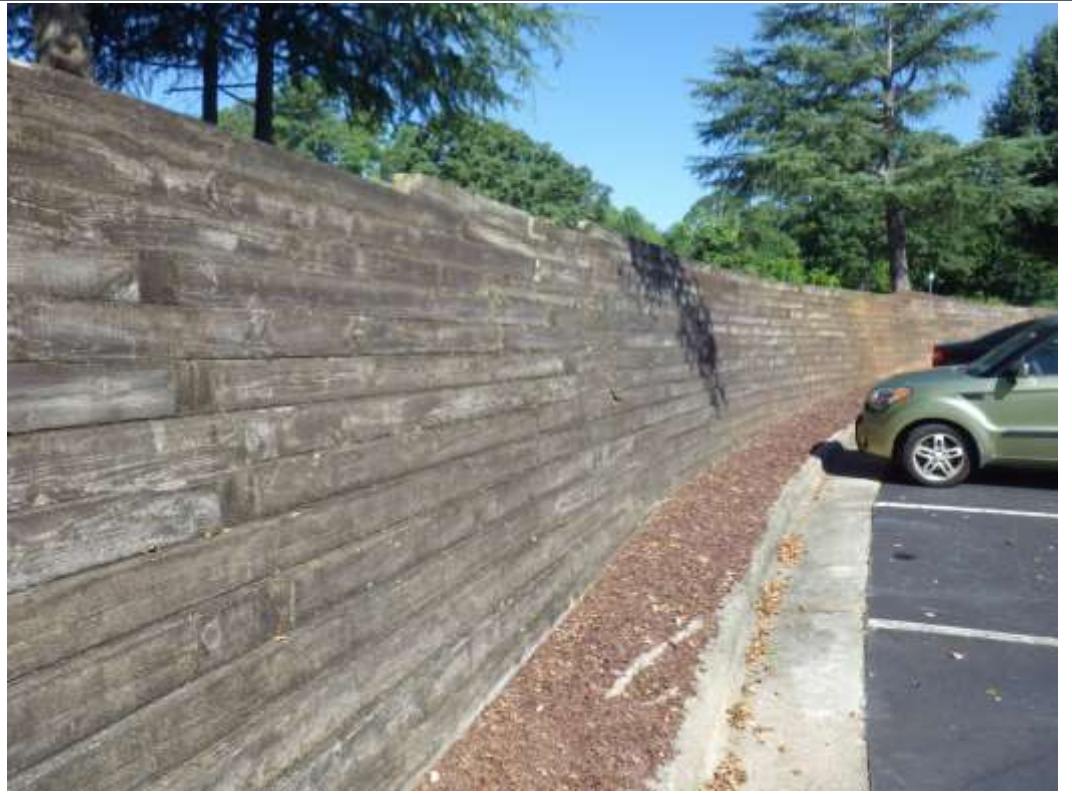
Photo No.
15

Location of proposed retaining wall behind building 300

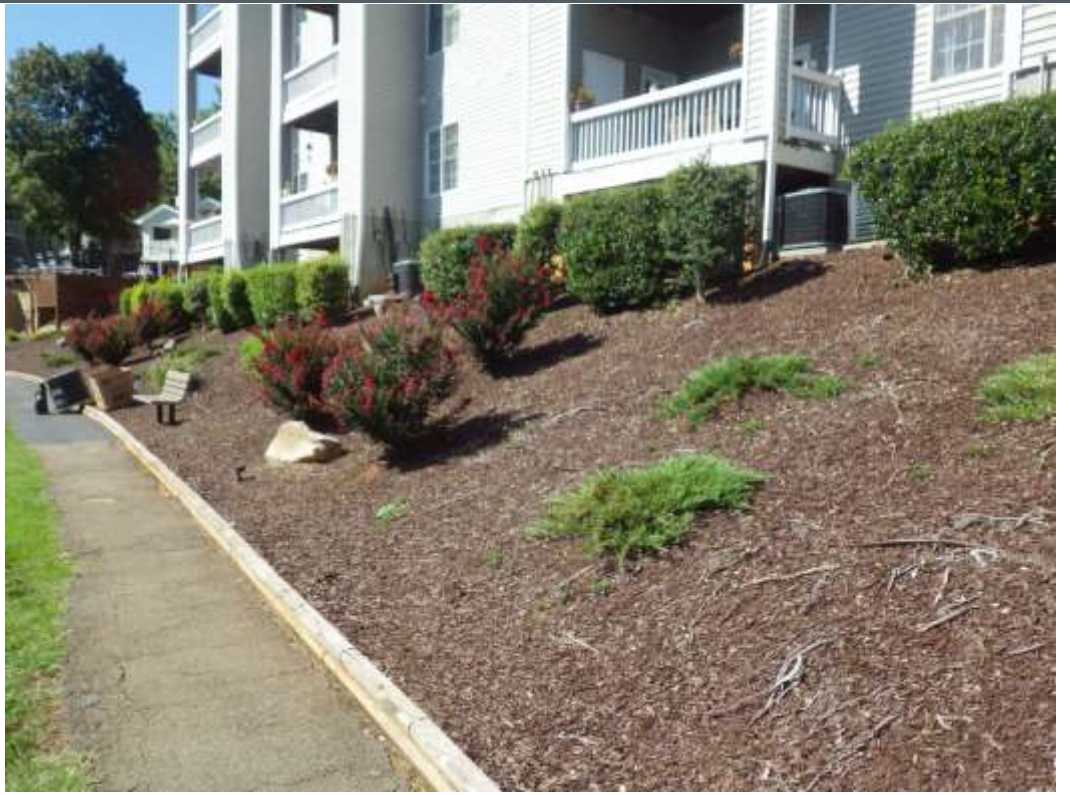
Photo No.
16

Typical condominium building front exterior

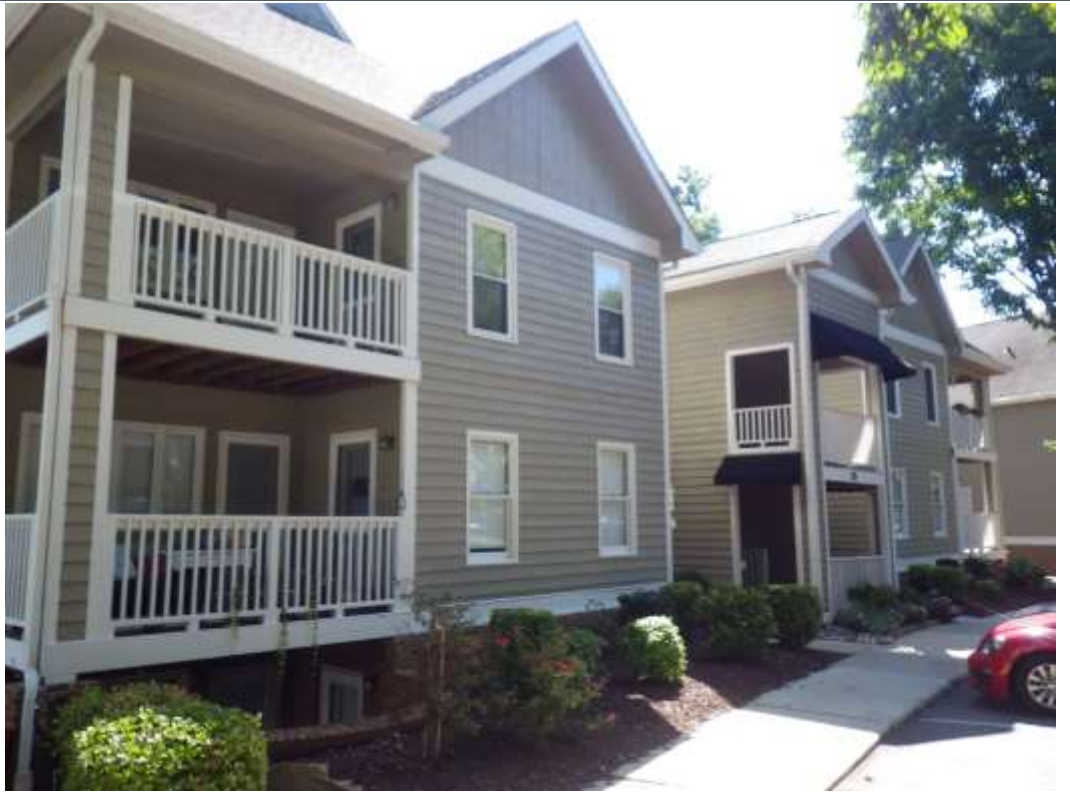
Photo No.
17

Typical condominium building rear exterior

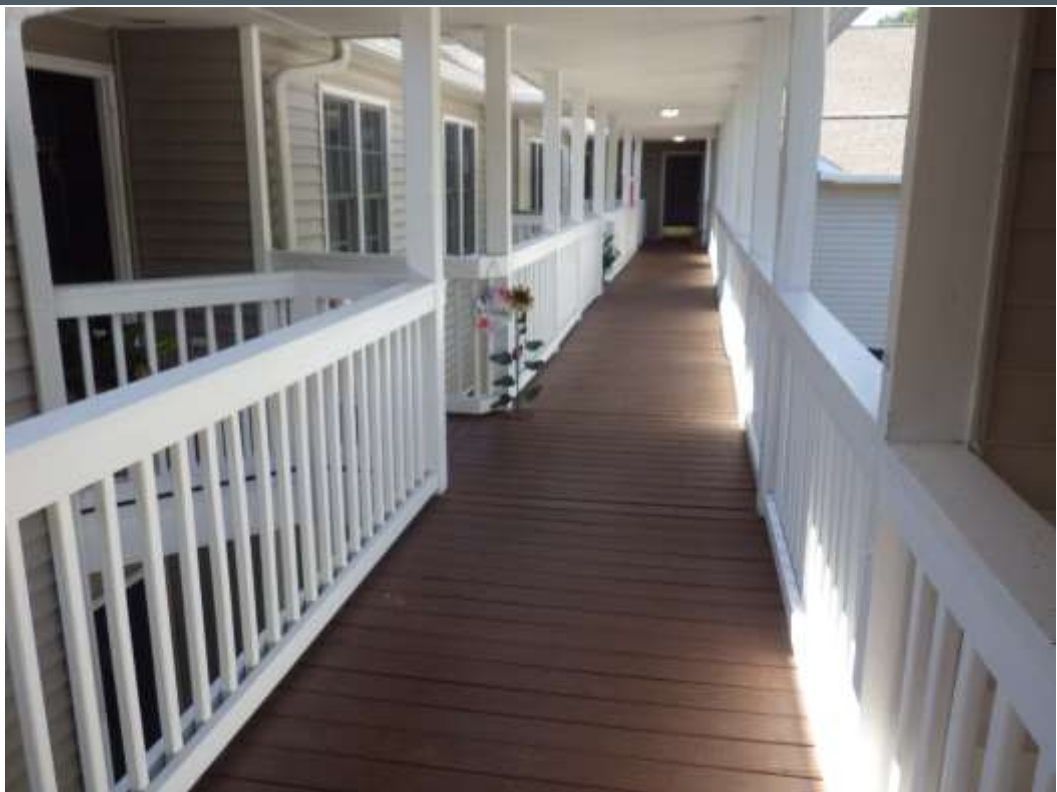
Description
Breezeway structure
Photo No. 19

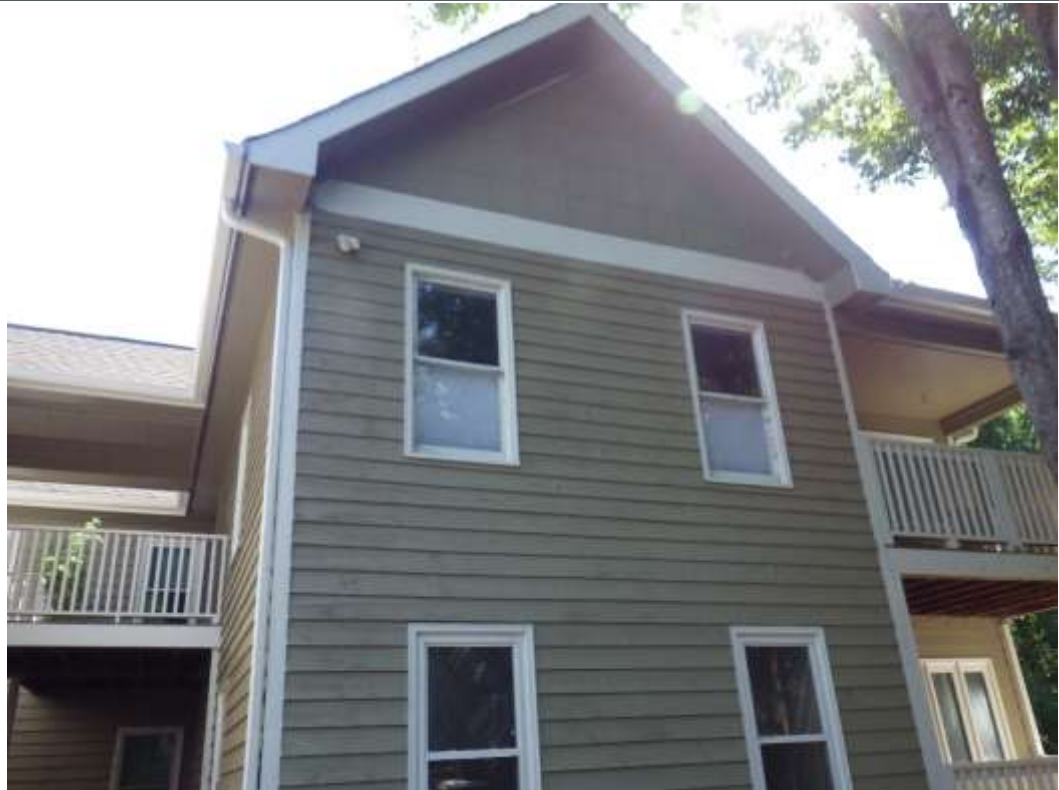
Description	 
Vinyl siding	
Photo No. 21

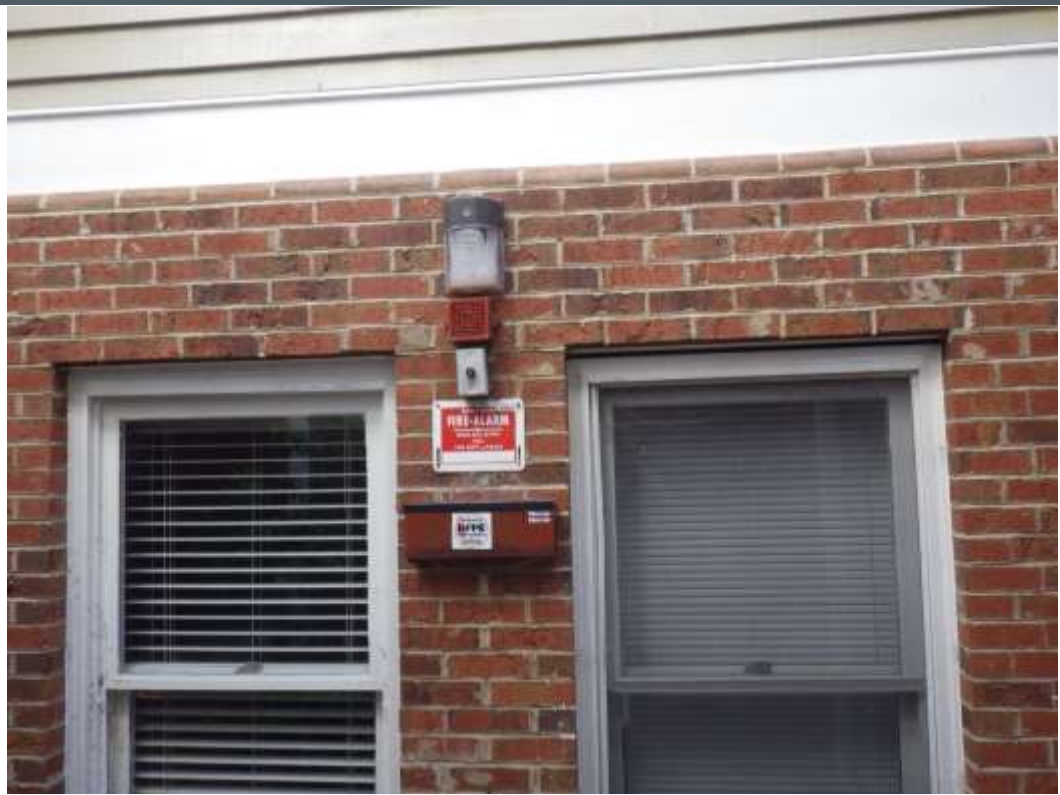
Description
Fire alarm components
Photo No. 25

inaccessible during the inspection. We have provided a funding allocation for repairs to the fire alarm system components on a 5-year cycle beginning in 2024.

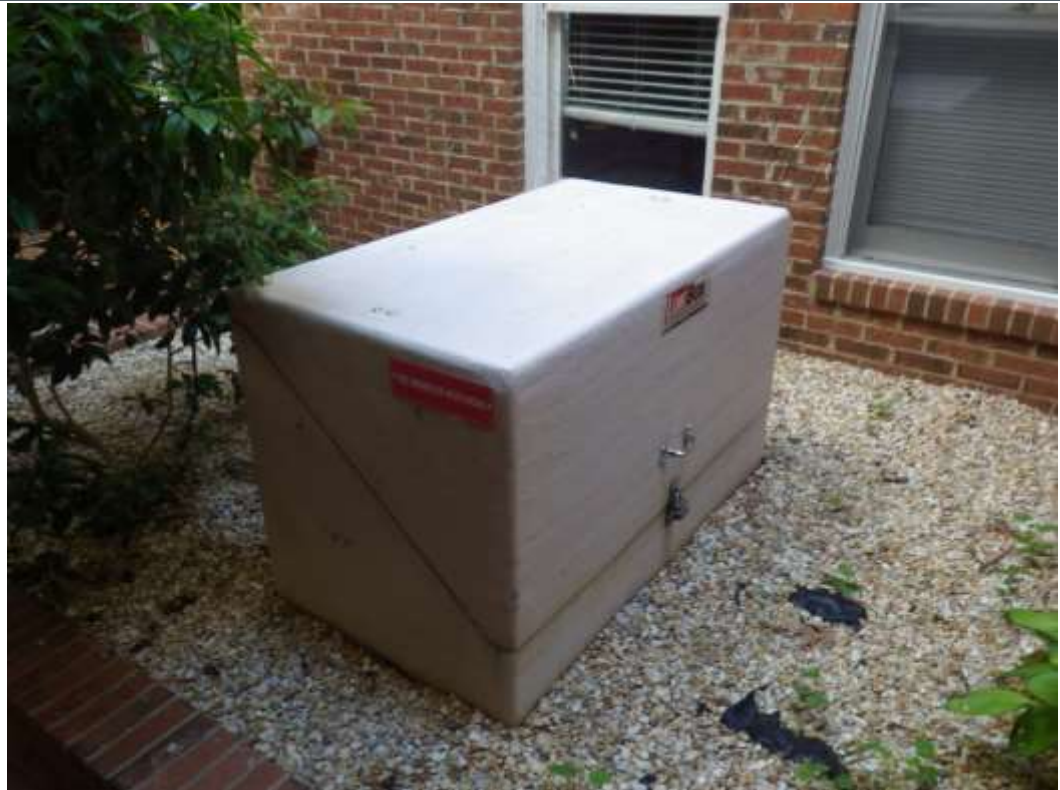
The buildings are each served by wet fire suppression system with riser in a small mechanical room at street level or contained in an insulated enclosure in the ground floor courtyard area of each building. It is likely that significant repairs to the valves, gauges and common area sprinkler heads will be periodically required. We have provided a funding allocation for repairs to the fire suppression system equipment on an 8-year cycle beginning in 2027.

Description
Fire riser assembly in insulated enclosure
Photo No. 26
